# **Accessibility to public transport: a best practice guide**

**October 2010**

C. O'Fallon  
Pinnacle Research & Policy Ltd, Wellington

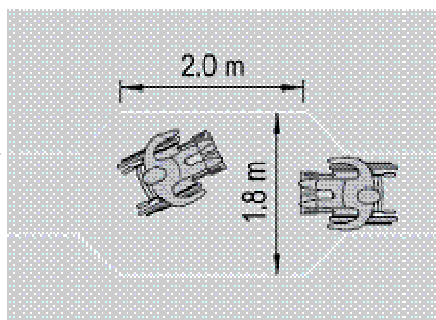
**Figure B1** Width of pedestrian passing places (source: NZTA 2008a)

Where a through route width is constrained to less than 1200mm wide, passing places should be provided so that two wheelchairs can pass each other and walking pedestrians can pass stationary pedestrians (see figure B1 below). Note that in suburban areas, residential driveways may provide such a passing opportunity.

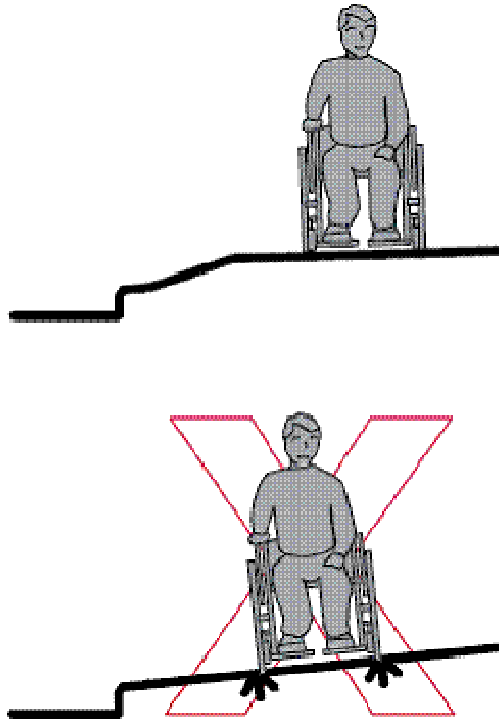
**Figure B2** Correct and incorrect provision of crossfall (source: NZTA 2008a)

A fully accessible footpath is free of single or isolated steps. The crossfall gradient (slope of the footpath at right angles to the direction of travel) should be less than 2% (1:50) – see figure B2.

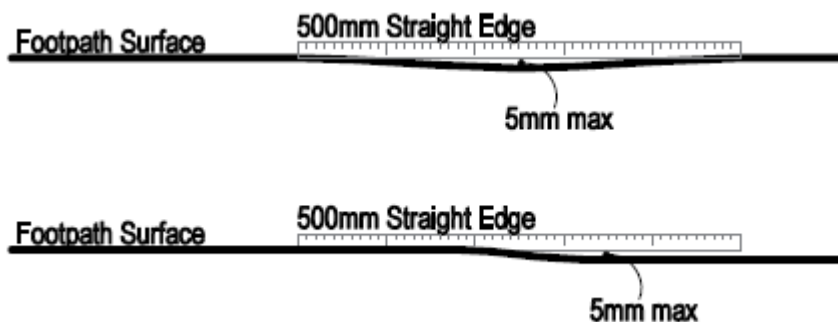
**Figure B3** Measuring changes in surface level (source: NZTA 2008a)

Sudden changes in the surface height of an otherwise even footpath surface should be less than 5mm; undulations in such surfaces should be less than 12mm.

Figure B3 illustrates how such deviation can be measured using a 500mm straight edge.

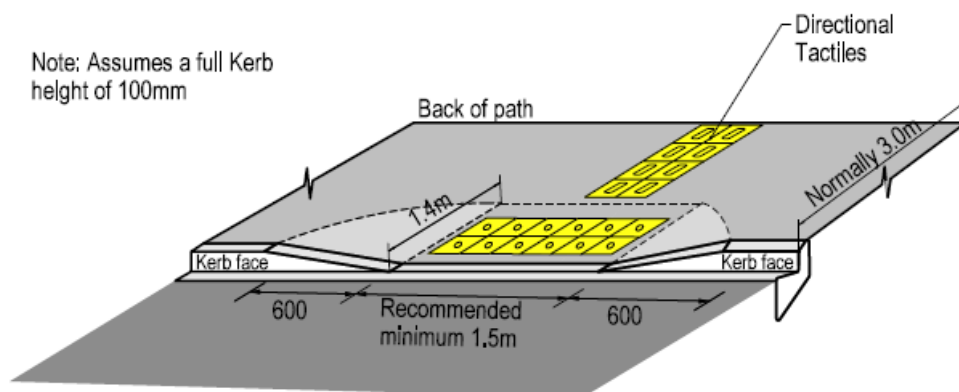
**Figure B5** Characteristics of ‘accessible’ kerb ramps (source: NZTA 2008a)

The NZTA (2008a) PPDG illustrates accessible kerb ramp design elements (see figure B5). The minimum width of the ramp (exclusive of flared sides) is 1000mm, based on current New Zealand statutory requirements (BF 2008); while the PPDG recommends 1500mm.

The normal maximum gradient/slope of the kerb ramp is generally no greater than 8% (1:12), although steeper gradients are tolerated in constrained conditions:

- a gradient of 10% should only be considered where the vertical rise is <150mm
- a gradient of 12% should only be considered where the vertical rise is <75mm.

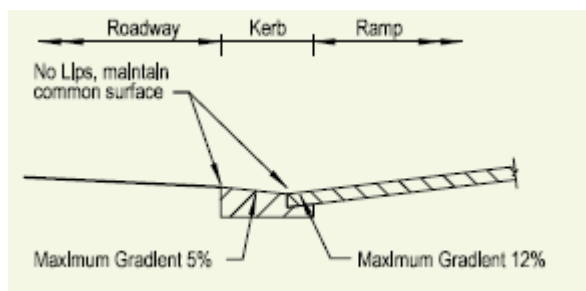
**Figure B6** Typical gutter design (source: NZTA 2008a)

The transition between the ramp and the road should be smooth, with no vertical face, as illustrated in figure B6.

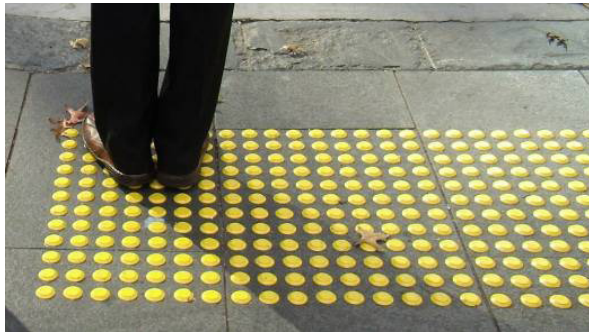
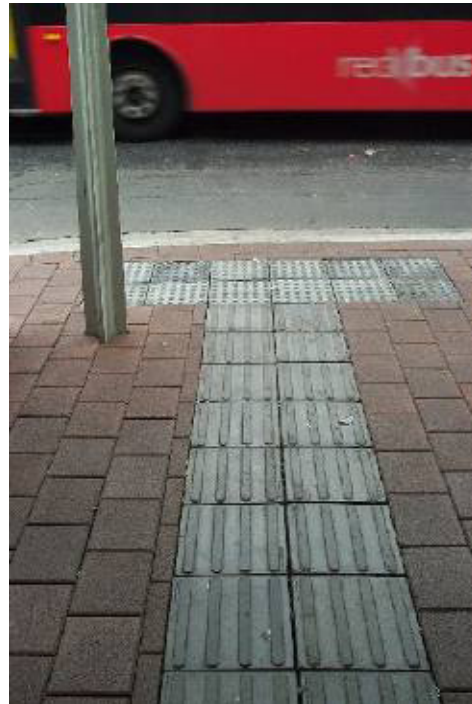
**Figure B7** Examples of tactile warning and directional indicators (source: NZTA 2007)

- The detectable warning surfaces, and their surrounding surfaces, should have a good visual contrast (colour, brightness, hue).
- For a kerb ramp, the detectable warning surfaces should cover the entire width of a kerb ramp, excluding flared sides.
- The detectable warning surfaces should have a depth of at least 600mm, set back at least 300mm from the hazard (usually the roadway).
- In the case of a bus stop, the detectable warning surfaces should be located close to the front entry door of a bus, have a minimum depth and width of 600mm and be installed 300mm back from the front kerb edge.
- Directional indicators 600mm deep should be installed where warning indicators are not located in the direct line of the continuous accessible route, so as to form a continuous path to the warning indicators.

Warning indicators

Directional and warning indicators installed at a bus stop

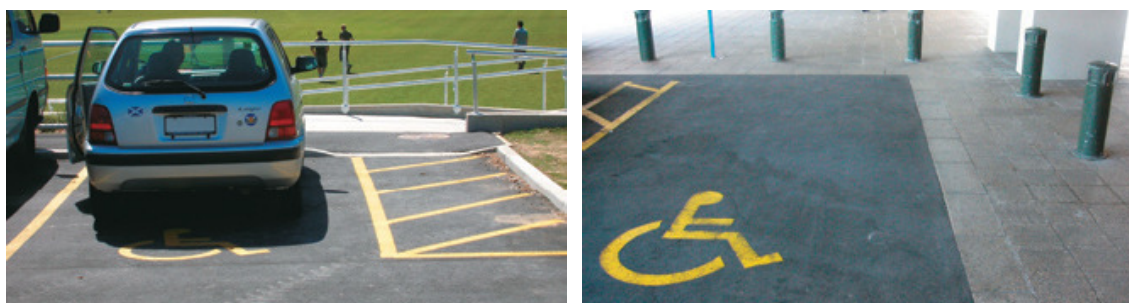
**Figure B9** Examples of accessible car parking (source: accessed August 2009 from [dbh.govt.nz/accessible-carparks](http://dbh.govt.nz/accessible-carparks))

Accessible car parking spaces should have a maximum slope of 1:50; be 3500mm wide; and a minimum of 5000mm (angle park) or 6300mm (parallel park) in length. An accessible park should be level with the footpath or have a kerb ramp for wheelchair users to gain access to the footpath. As with accessible routes, the car park surface should be stable, firm and slip resistant, and the car park area adequately lit between dusk and dawn. The accessible car parks and the accessible route should be covered overhead.

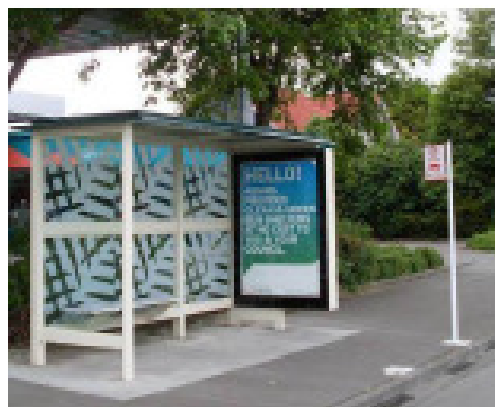
**Figure B13** Example of accessible bus shelter and bus stop signage (source: PNCC 2009)

Figure B13 provides an example of an accessible shelter and appropriate bus stop signage found in Palmerston North. Note the bus stop sign is 1500mm away from the shelter, allowing wheelchair access. Ideally, it should also be located further ahead of the shelter (rather than directly opposite the shelter, as shown here), so that the sign does not obstruct wheelchair users who may be in the shelter. Furthermore, there is no tactile paving to warn visually impaired users of the location of the kerb.

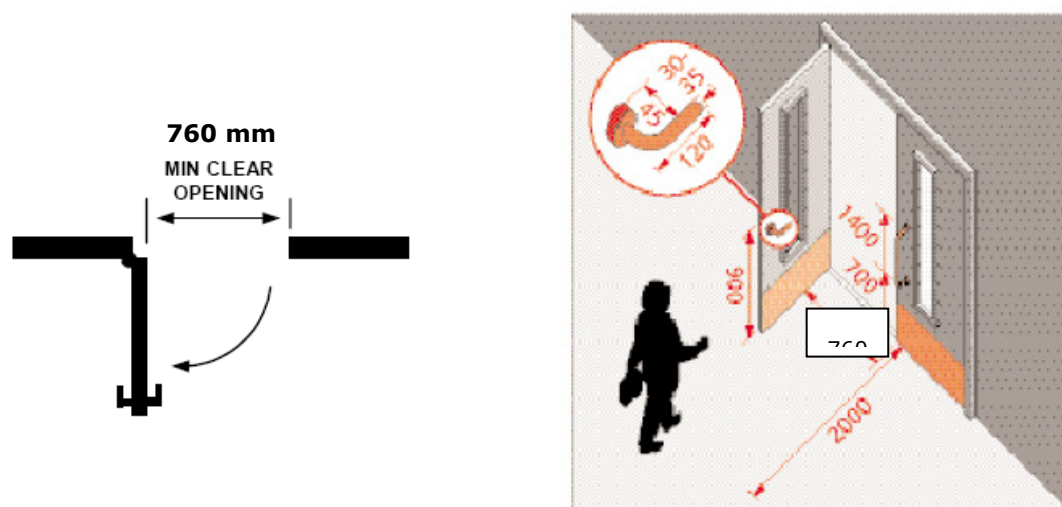
**Figure B15** Station entrance doors, doorways and handles (source: adapted from Kentucky Dept of Vocational Rehabilitation 2000 and UK DFT 2002)

In a long or large station, it is expected there will be more than one accessible entrance. Ideally doors at accessible entrances will be fully automated. However, figure B15 illustrates the characteristics of accessible manual doors.

A minimum of 1200mm by 1200mm level, clear space should be available on both sides of the entrance/doorway. (Note: if the width of the door itself is included, this would measure approximately 2000mm out from the doorjamb, as shown in figure B15). If there are two or more doors in a series, there should be 1200mm between the two doors, when they are both open, so that a wheelchair can back up and turn clear of a swinging door. Where the entrance to a station has a revolving door or turnstiles, either the accessible doorway should be adjacent to it or have its location clearly signposted.

Both manual and automatic doors should be fitted with delay-action or slow action closure mechanisms that apply minimum closure pressure. Manual doors should be able to be opened with minimal force (38N for exterior hinged doors and 22N for interior hinged doors). Handles, pulls, buttons, or other operating devices should be operable with one hand and located between 900mm and 1200mm from the floor. There should be a clear panel providing visibility through the entrance/doorway, so that people can see people coming from the other direction.

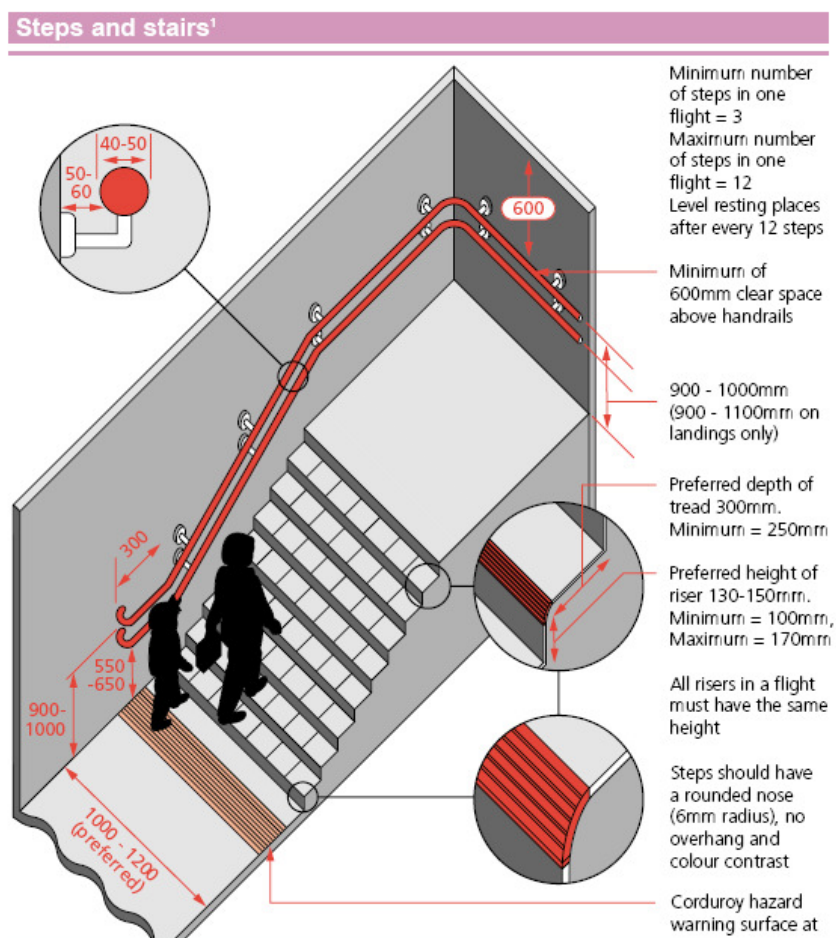
Figure B16 Steps, stairs and handrails (source: UK DFT 2002)

Figure B16 illustrates some characteristics of accessible staircases (handrail characteristics are discussed in section B5.4). Further details about steps are shown in figure B17. While the step riser height can be between 100mm and 170mm (ie no more than 180mm), it is important that the riser height is uniform for the entire flight of stairs. The step tread should be at least 31mm deep; have a rounded, contrasting-coloured leading edge or nosing; and be covered in slip-resistant material. The steps should be at least 900mm wide between handrails for the entire flight (ie at least 1000mm wide from wall to wall or handrail mounting to handrail mounting).

Handrails should be provided along both sides of the ramp or stairs, and should be continuous around landings (except at doorways). They should extend no more than 300mm beyond the top and bottom of the ramp or stair segment, and the top surface of the handrails should be mounted between 900mm and 1000mm above the floor. All handrails should be securely fixed and stable in their fittings, and able to carry the full weight of a person. The clearance from the wall is 45mm to 60mm; and their outside dimension is 32mm to 50mm – both dimensions are a slightly wider range than that shown in figure B16 for the UK.

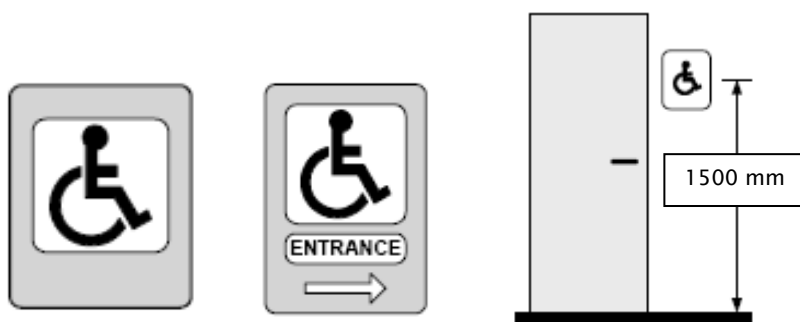
Figure B20 International sign of access (Source: adapted from Kentucky Dept of Vocational Rehabilitation 2000)

All accessible entrances to the station should display the 'international sign of access' at a height of 1500mm from the floor (NZS 4121: 2001 Design for Access and Mobility) as illustrated in figure B20.

<b>A20-S20</b>	<b>Wheelchair access</b>		
	<i>Indicates a place where wheelchair access is provided.</i>		
<b>Legend</b>	<b>Description</b>	<b>Colour</b>	<b>Size</b>
	'symbol of person in wheel chair'	white	240 x 300 mm

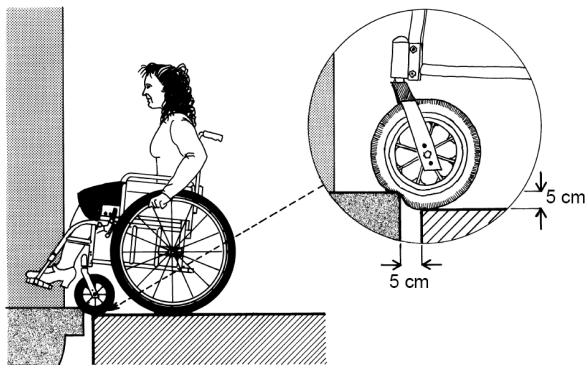
**Figure 21B** Illustration of vertical and horizontal gaps between platform and train carriage (source: COST 335 1999)

The recommended horizontal and vertical gaps between the platform and carriage for wheelchair users are illustrated in figure 21B.

Where steps are provided, the vertical gap between the platform and the bottom step, and the height of each step when there are more than one, should be  $\leq 220\text{mm}$ . The depth of the tread should be  $\geq 300\text{mm}$ .
